Improved glass conveyor chain for higher productivity

Ramsey Products Corporation, Charlotte, North Carolina (USA)

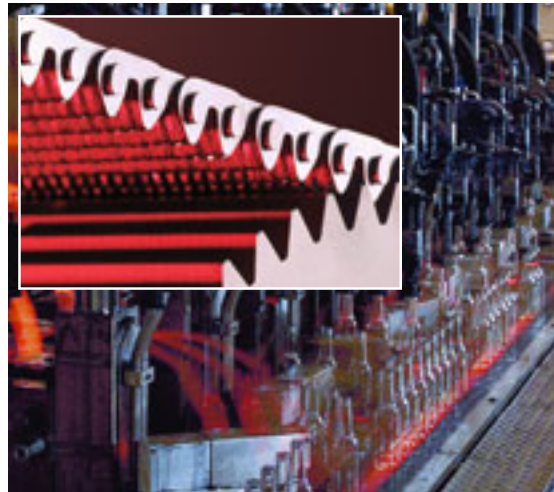
UltraLife chain close-up, and on an IS machine

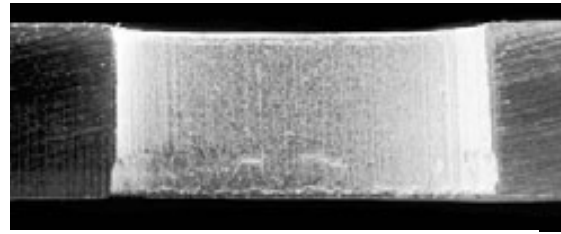
Fig. 4 Cross-section of Ultralife link aperture 20x

Changes were then made in the chain design and the manufacturing processes employed. First, building on techniques developed for use in high-speed power transmission chain, specialized tooling was developed to improve the quality of the conveyor link apertures. The improved links have a smoother aperture surface and a significantly higher bearing area for pin support. Unlike standard conveyor chains, where approximately 65% of the link thickness is in contact with pins, the new links provide over 80 % of the link thickness as a bearing surface. The increased bearing area reduces bearing stresses by nearly 20% and significantly decreases the rate of link joint wear. An additional benefit of the improved link production method is better control of chain pitch. The pitch of individual links is more consistent, with less variation between manufactured lots.

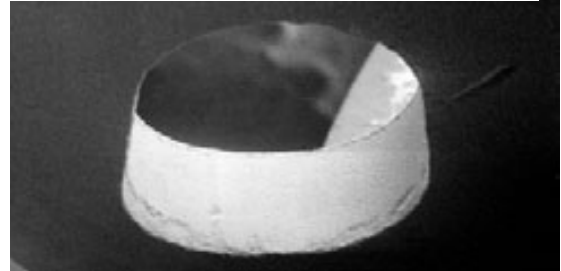
Fig. 5 Ultralife link aperture surface 15x

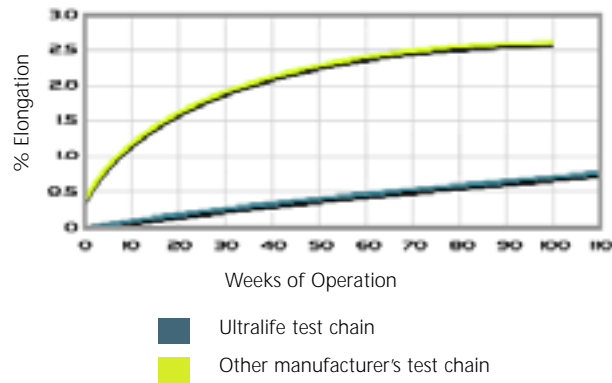
Fig. 6 Ultralife chain elongation compared to another manufacturer's published data

For the next nine months of operation, no chain maintenance was required. After a little more than nine months, the chain was re-tensioned by adjusting the drive sprocket. The magnitude of the adjustment indicated that the chain had elongated approximately

76mm. Twenty-three months later, after a cumulative run time of thirty-two months, a similar adjustment was made to take up an additional 152mm of elongation. Both of these adjustments were made while the chain was running, requiring no additional machine downtime. Finally, in September of 2000, after thirty-four months of run time, the chain was removed and replaced, even though the chain was operating satisfactorily. Bill Edmonds, the hot end engineer, explained that the chain was running fine, but we decided to replace it anyway while the machine was shutdown for other maintenance. During the entire thirty-four months of the chain test the machine was not shutdown for chain maintenance. According to Bill, "After thirty-three years in the glass business, the Ultralife chain is the finest conveyor chain I've ever worked with."
